**Design and Access Statement:
23 Glenhurst Avenue
NW5 1PT**

May 2026

This document is provided in support of an application for retrospective Householder Planning Permission for works comprising:

new timber structures to south west of main building

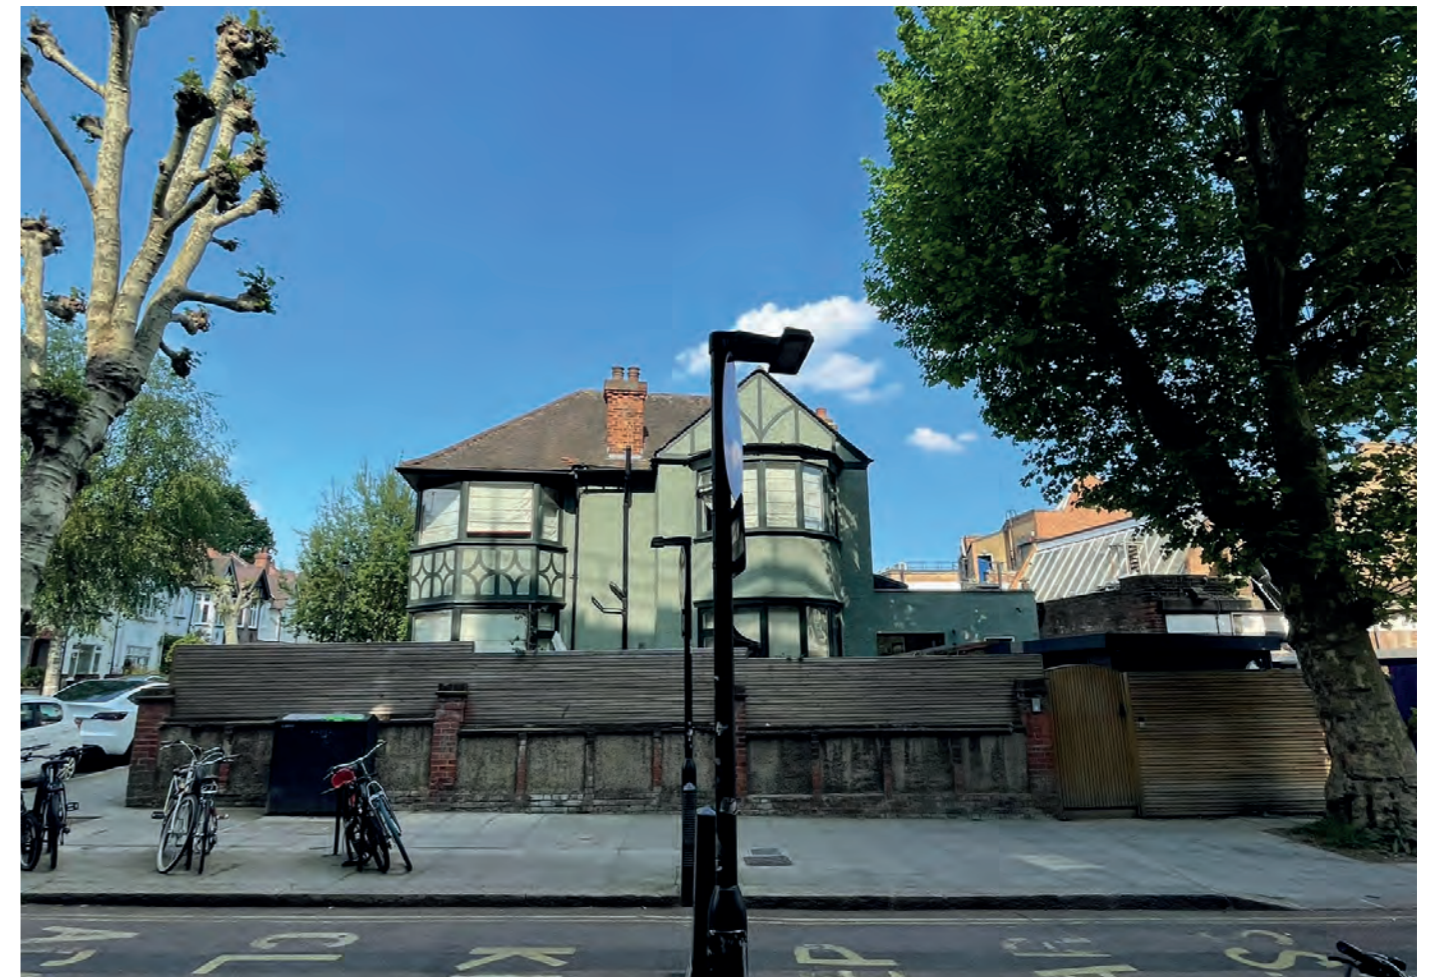
No. 23 Glenhurst Avenue - west elevation from Lissenden Gardens May 2026

- The west elevation has two distinct elements; the main house of two storeys & roof, and a flat roofed single storey extension at the rear of site, originally a garage. Review of historic maps suggests this to be the original arrangement of the property (as Section 5, p 14 of this document).
- The masonry boundary wall on the west elevation stops in line with the end of the main house.

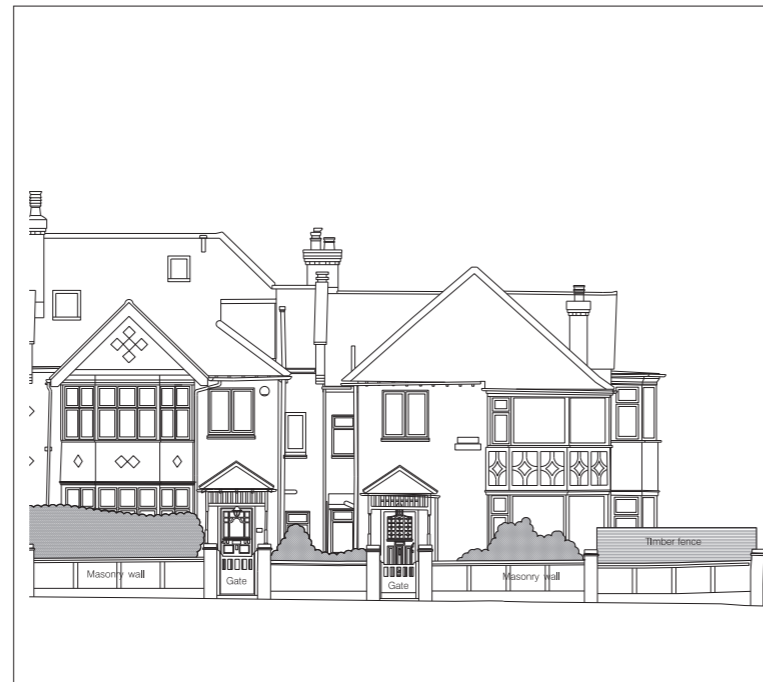
Existing North / Glenhurst Avenue elevation

- The north elevation shares the Arts & Crafts styling of Glenhurst Avenue, but the roof profile is lower than its immediate neighbour
