## Tree Survey: Bay Tree

**Tree Species:** Laurus nobilis (Bay Tree) – Category C: Tree of low quality and value

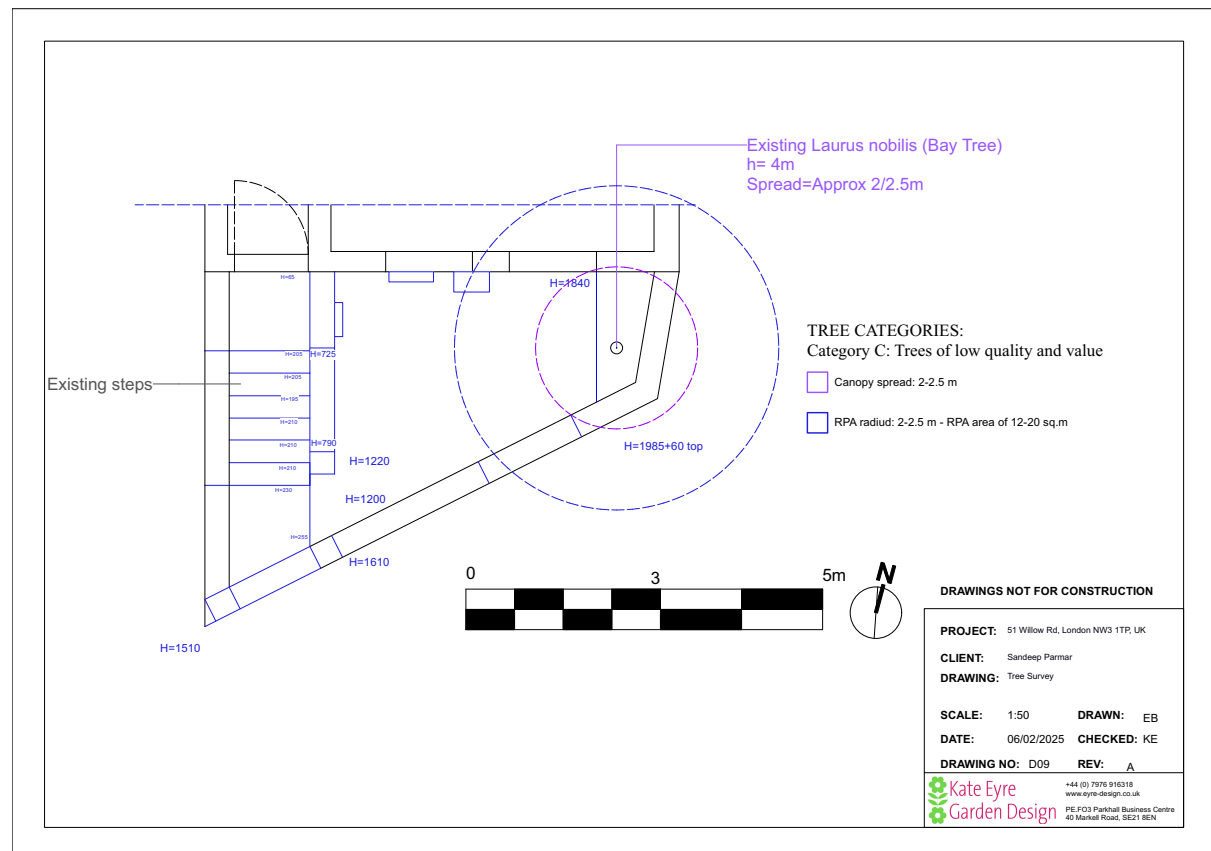
**Height:** Approx. 4 meters

**Canopy Spread:** Approx. 2.5 meters (calculated based on the typical spread-to-height ratio of mature bay trees in similar conditions)

**Condition:** Good – The tree is healthy with no visible structural or disease-related issues.

- The tree is overgrown and has outgrown its current space.
- Its size has the potential to exert pressure on the nearby retaining wall over time.
- The dense canopy obscures natural light from entering adjacent windows, impacting the interior ambiance of the property.

We propose removing the bay tree to mitigate potential structural risks to the retaining wall and to allow more natural light to pass through to the windows. In its place, we suggest planting a selection of tall shrubs or ornamental plants to maintain greenery in the area while complementing the newly designed bin storage. These plants will be selected for their suitability to the site, low maintenance, and aesthetic contribution to the overall design.
