**19 TANZA ROAD  
HAMPSTEAD HEATH  
LONDON  
NW3 2UA**

Flood Risk Assessment  
March 2026  
P02

MBP has been commissioned by the Client to undertake a Flood Risk Assessment (FRA) in support of a planning application for proposed works at 19 Tanza Road, London, NW3 2UA, including works to the existing lower ground floor level, comprising the lowering of the floor finish level and associated alterations.

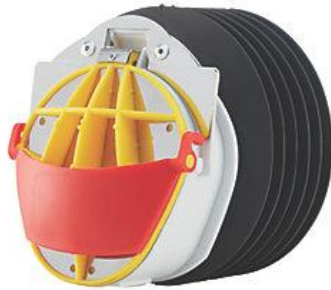
- non-return (anti-flood) valves such as the Buffalo Non return valve;

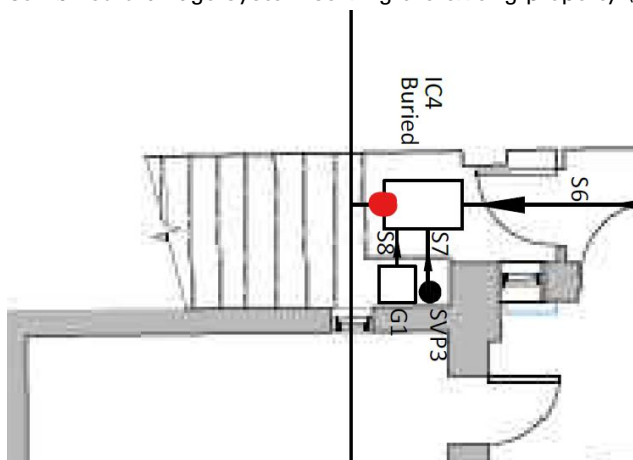
- The anti-flood valve will be located within the last existing manhole on the private combined drainage system serving the exiting property (red dot below)

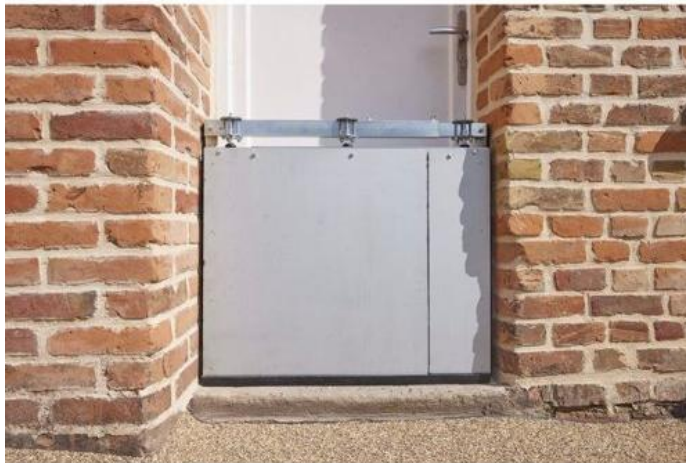
- a demountable flood barrier at the site entrance (example below); and
